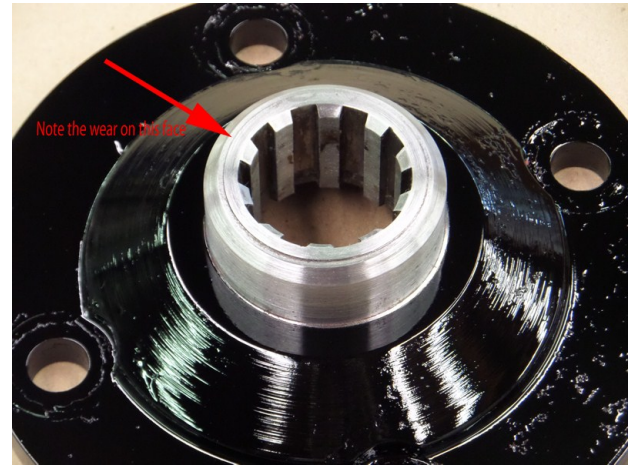
Inspect the rear of flange for wear and chamfer. The chamfer on some flanges will be too large causing excessive wear . This can also cause wobble and run-out. If your flange looks like this take about .035 off this surface using a milling machine or lathe. Put a small chamfer on the ID. Slide it on the trans and check to make sure that there is still clearance at the seal.

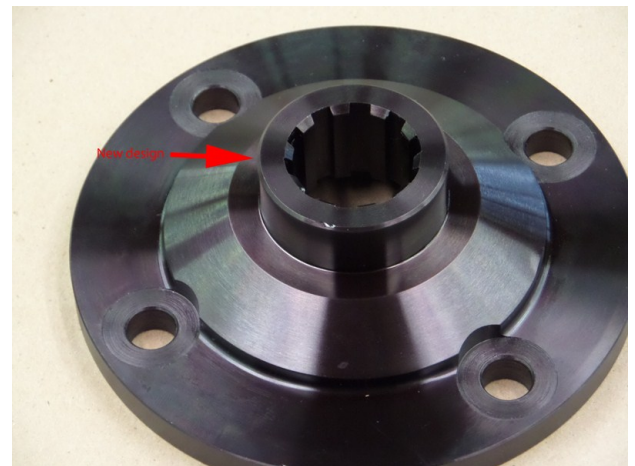
Our newer flanges have a much smaller chamfer. Upon final installation this surface will get a **thin** coat of sealer. We use Mercury Perfect Seal but almost anything will work.

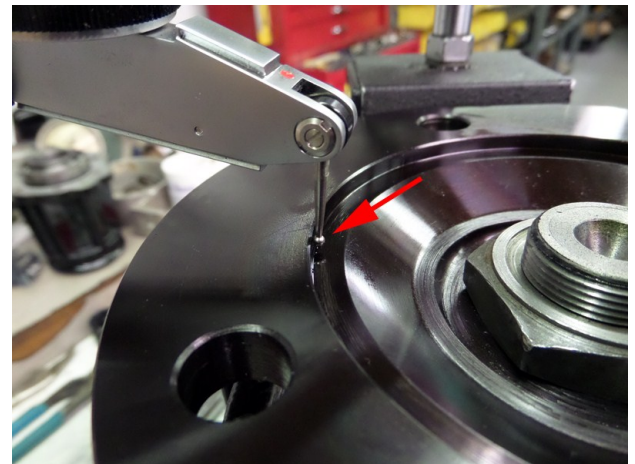
Once the chamfer has been inspected/corrected setup the transmission nose down using some kind of support to keep the weight off the input shaft. A couple of 2x4's are fine. Install the flange and tighten temporarily. It helps if you have an old nut with the nylon removed. Set up a dial indicator on the ID of the pilot bore. Rotate the flange and check for run-out. The maximum allowable TIR is .0025. If not within spec remove the flange and move it 1 tooth on the shaft and check again. Feel free to try and find the spot with the least run-out.

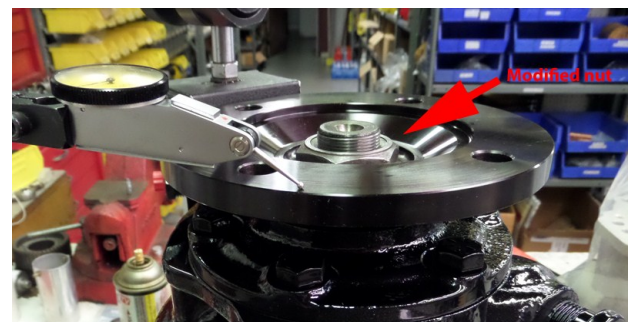
Once you have found the sweet spot for the run-out set up the indicator at the very OD of the flange and check for wobble. Wobble is usually caused by a bent flange. This is not as critical as the run-out but we shoot for .003 max. There is not much you can do to correct this unless you have access to a lathe and an ID mandrel. Finally remove the flange, put a **THIN** coat of sealer on the rear. Install a new nut using Loctite and torque to 175 ft lbs.
